2022 Annual Monitoring Report

McGarry Waste Disposal Site
Township of McGarry, Ontario

February 27, 2023

Pinchin File: 304108.000

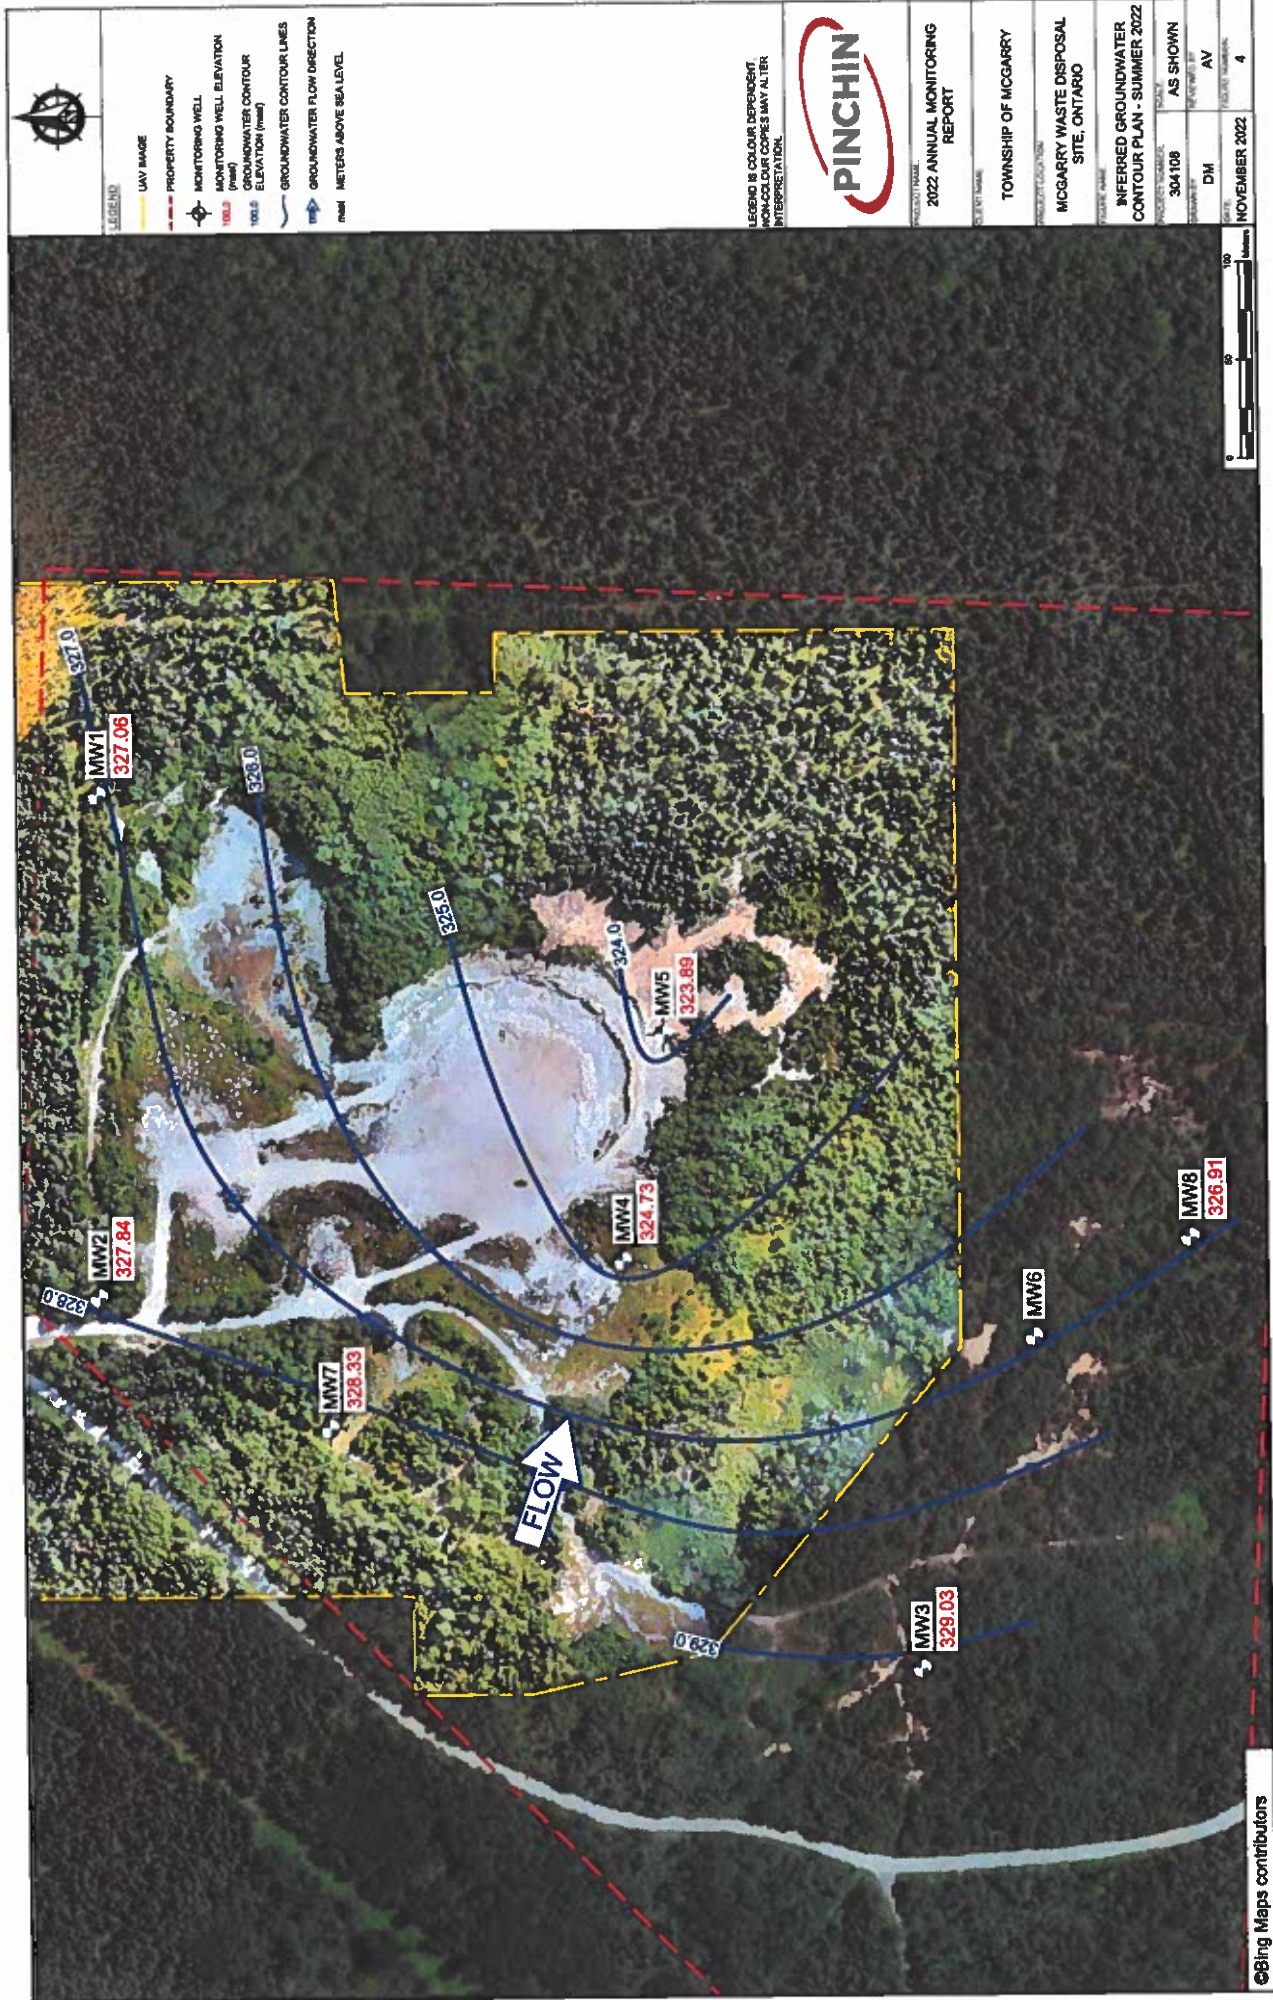
- LEGEND**
- UAV IMAGE
 - PROPERTY BOUNDARY
 - MONITORING WELL
 - MONITORING WELL ELEVATION (feet)
 - GROUNDWATER CONTOUR ELEVATION (feet)
 - GROUNDWATER CONTOUR LINES
 - GROUNDWATER FLOW DIRECTION
 - feet METERS ABOVE SEA LEVEL
